CLOSE CALL SURFACE DUMP POINT ACCIDENT

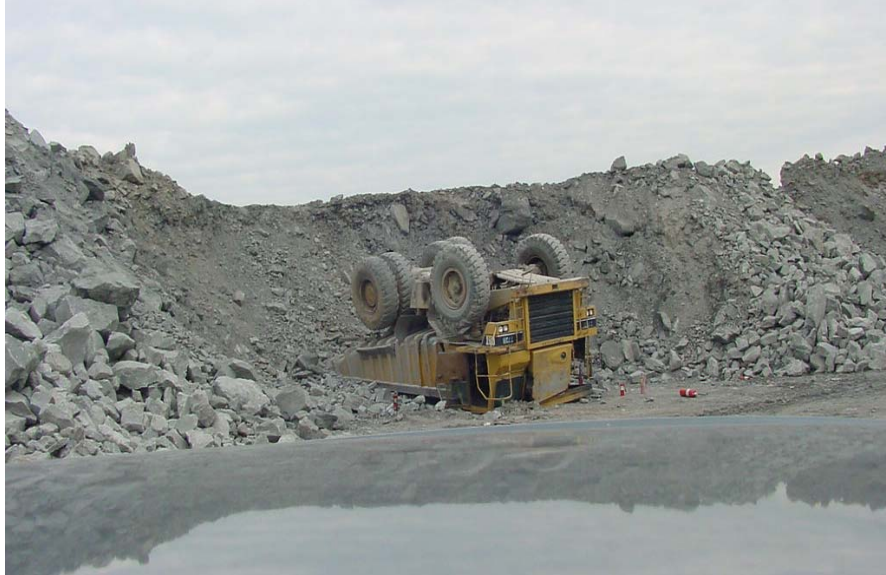
On December 5, while dumping on a stockpile, the rear of the haul truck dropped suddenly, impacting the slope and flipping upside down on to the ground below. The haul truck's rear tires had encountered soft material in an over steepened state due to load out activities conducted below the dump point. The driver suffered severe, permanently disabling injuries due to the accident.

1. Always maintain an adequate berm.
2. Dump short, or in another area if load out activities have taken place below the dump point.
3. Make frequent examinations of the dump point.
4. Maintain communication between those working on the dump point, and those loading out below the dump point.
5. Wear seatbelts.
6. Provide adequate task training for employees.
